FLYER TO THE LEISURE INDUSTRY

ORCA: accident leading to a fatality on 8 June 2014

Marine Accident Investigation Branch
May 2015

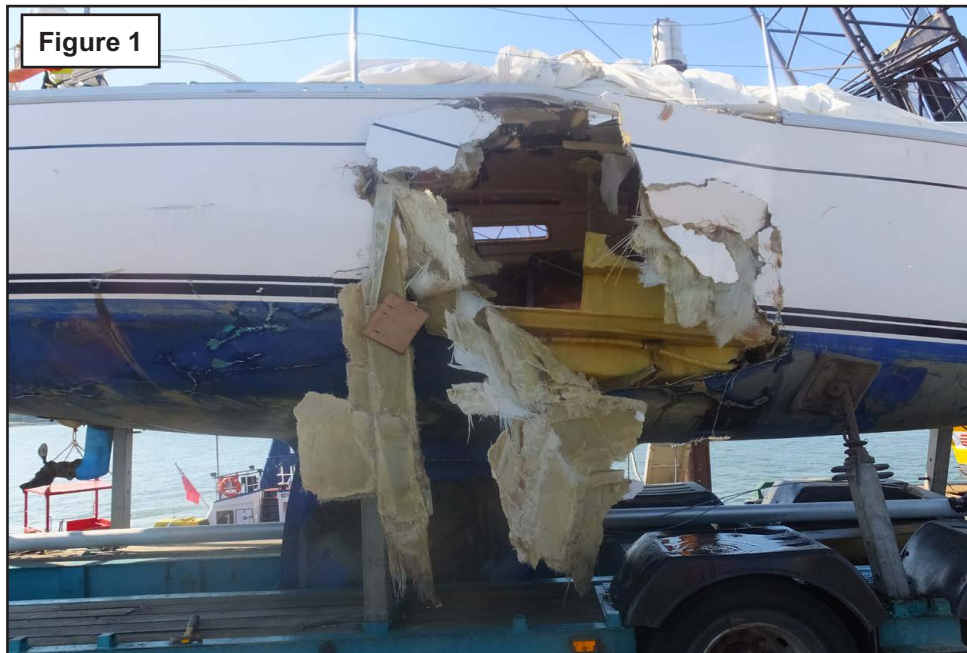
Figure 1

At 1331 on 8 June 2014 the dredger *Shoreway* and the sailing yacht *Orca* collided 7 miles off Felixstowe. Damage to *Orca* was catastrophic (**Figure 1**) and it sank within minutes of the collision. The yacht's skipper was rescued from the water by *Shoreway*'s rescue boat but the skipper's wife could not be found despite an extensive air and sea search. Her body was recovered from the sunken yacht by divers the next day. There was no damage to *Shoreway*.

The MAIB investigation found that the vessels collided in good visibility as neither the chief officer, who was alone on the bridge of *Shoreway*, nor the skipper of *Orca*, who was below deck in the cabin, were maintaining a proper lookout in the period immediately prior to the collision.

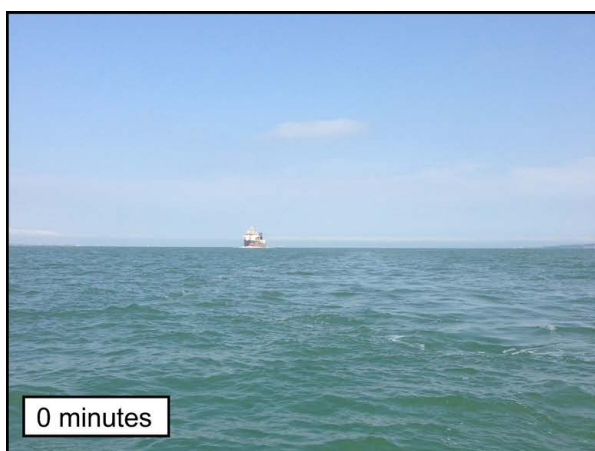
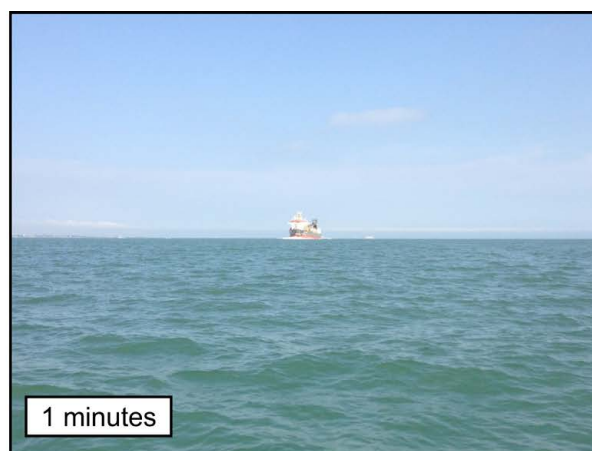
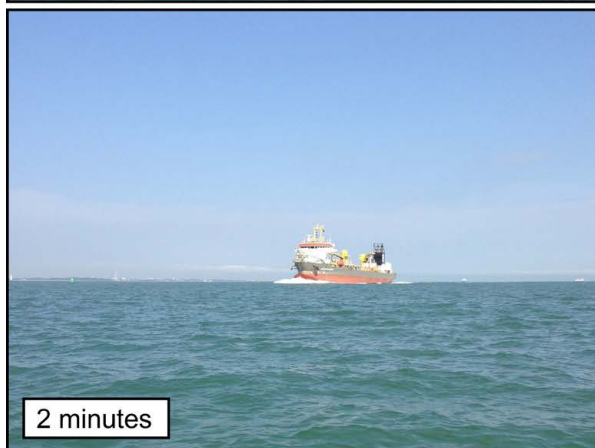
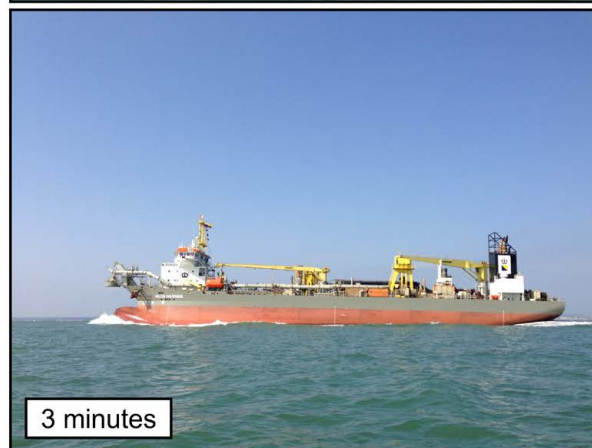
The following four pictures, taken from a stationary vessel, give an indication of how rapidly a vessel, in this case a dredger, can approach.

- Leisure sailors need to be particularly aware of closing speeds between their own vessels and other vessels. In this case, *Shoreway* was travelling at 12.9kts but many types of vessels, including ferries, cruise ships and container ships, regularly sail at speeds over 25kts and, as a result, distances that initially appear sufficient can be reduced surprisingly quickly.
